# Manhole Inspection Summary

Manhole # S19K1\_021MH

Insp Date: **5/1/08 10:07 AM**

**Location** Address: **2411 elizabeth av**

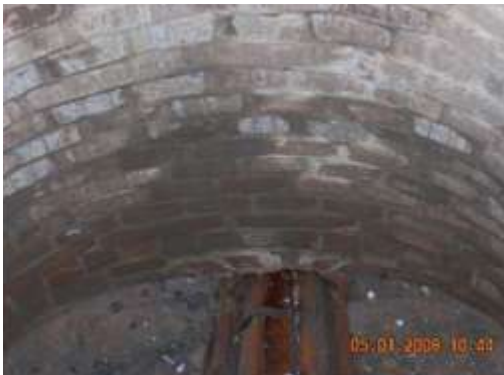
Defect 2

Infiltration: ☐ None ☐ Joint ☐ Cracks ☐ Mortar ☐ Roots ☒ **Wall**

infiltration @ barrel wall

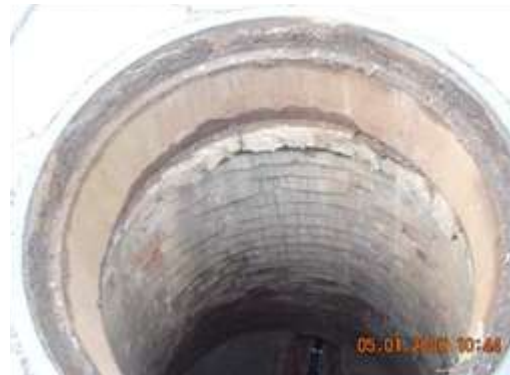
Defect 1

Infiltration: ☐ None ☒ **Joint** ☐ Cracks ☐ Mortar ☐ Roots ☐ Wall

chimney inflow evidence

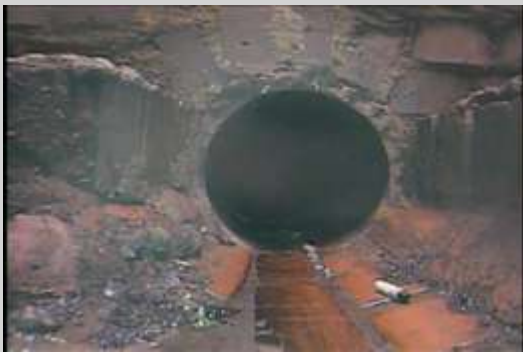
12 O'Clock Outflow

8 in. Circular Gravity Sewer  
Pipe Out @ 12 O'Clock

Pipe Height: **8.4** (in.) Rod and Bar (Angled)  
Pipe Material: **Clay** ☐ Pipe Lined  
Invert Depth: **7.85** (ft.) Flow Characteristics: **Slow**  
Deposits: ☒ None ☐ Mud ☐ Sludge ☐ Debris ☐ Grease  
Silt Depth: **0** (in.) Deposits Extent:  
Infiltration: **None** Pipe Seal Cond: **Sound**

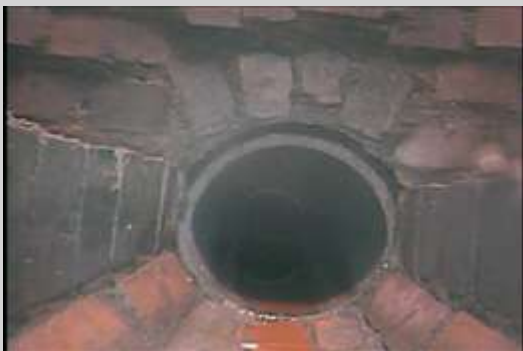
6 O'Clock Inflow

8 in. Circular Gravity Sewer  
Pipe In @ 6 O'Clock

Pipe Height: **8.4** (in.) Rod and Bar (Angled)  
Pipe Material: **Clay** ☐ Pipe Lined  
Invert Depth: **7.83** (ft.) Flow Characteristics: **Slow**  
Deposits: ☒ None ☐ Mud ☐ Sludge ☐ Debris ☐ Grease  
Silt Depth: **0** (in.) Deposits Extent:  
Infiltration: **None** Pipe Seal Cond: **Sound**

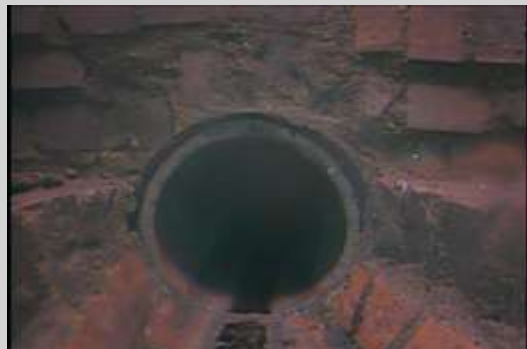
9 O'Clock Inflow

8 in. Circular Gravity Sewer

Pipe In @ 9 O'Clock

Pipe Height: **8.4** (in.) Rod and Bar (Angled)

Infiltration: **None** Pipe Seal Cond: **Sound**
